# THERMAL ANALYSIS OF SIX HEAT-REFLECTIVE EXTERIOR PAINTS ON CONCRETE UNDER RADIATION

- KNOWLEDGE CREATES PROGRESS®
- **▶** GWP WHITE PAPER PROL 007
- AUTHOR

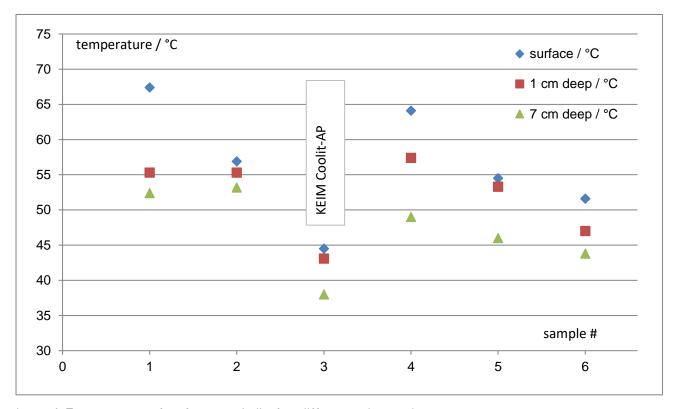
Image 1: Temperatures of surfaces ans bulk after different paint coatings

- The tested KEIM product achieved in comparison with the other samples the lowest surface temperature:
- and the lowest temperature in the concrete body.

Some of the paints tested have less of an effect, some have virtually no influence compared to the uncoated concrete, some heat the surface of the concrete faster than in comparison with the untreated concrete.

GWP # 12975	SampleN o.	RT /°C	Surface /°C	1 cm /°C	7 cm / °C	Description
div.	1	21.7	53.6	52.7	50.6	Uncoated concrete slabs
-1-02	2	20.0	67,4	55,3	52,4	Acrylic exterior paint B
-1-03	3	20.0	56,9	55,3	53,2	Acrylic exterior paint B + TSR
-1-02	5	20.4	44,5	43,1	38	KEIM Coolit-AP
-1-04	7	19.6	64,1	57,4	49	Acrylic exterior paint A with IR
-1-05	8	20.0	54,5	53,3	46	Acrylic exterior paint N with IR
-1-06	9	19.7	51,6	47	43,8	Acrylic exterior paint S with IR

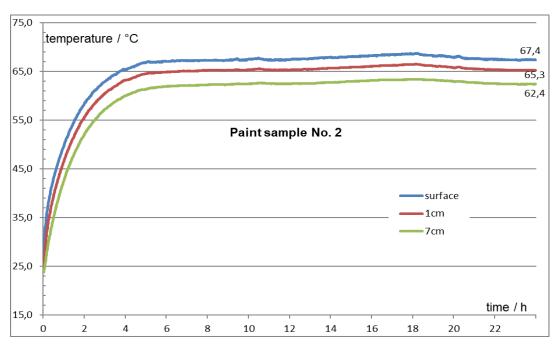
Image 2: Acrylic exterior paint B

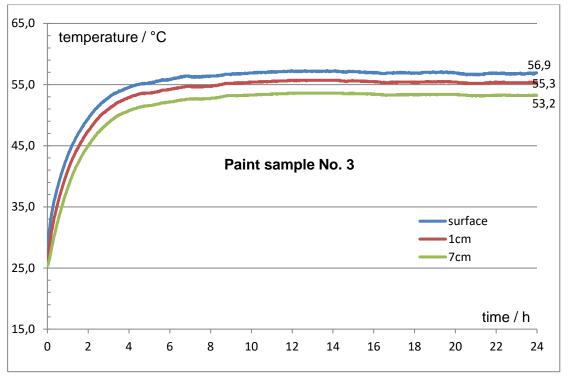
Image 3: Acrylic exterior paint B + TSR

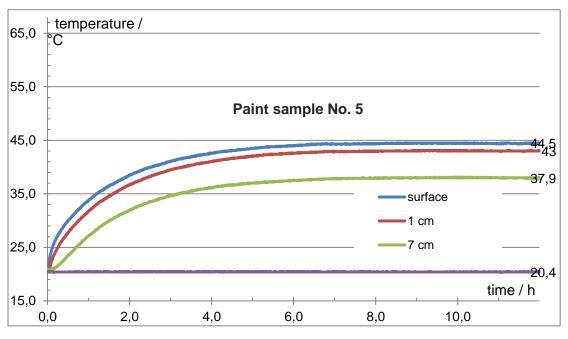
Image 4: KEIM Coolit-AP

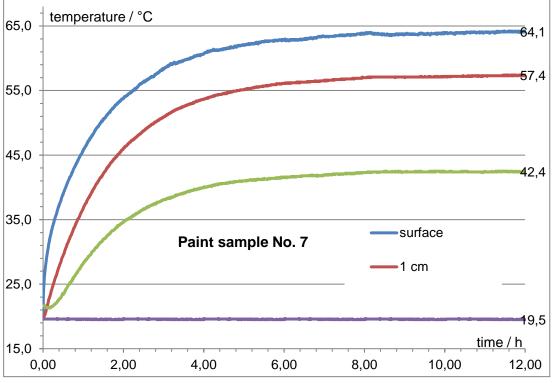
Image 5: Acrylic exterior paint A with IR

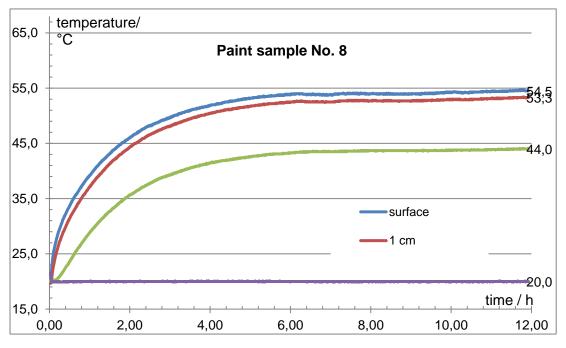
Image 6: Acrylic exterior paint N with IR

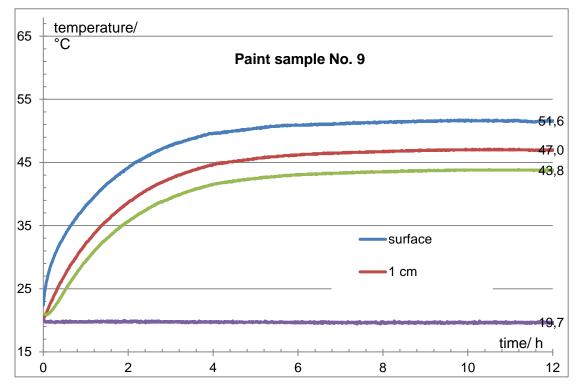
Image 7: Development of surface and bulk temperature by irradiation overtime

After a drying time of 2 days, the painted concrete blocks were exposed to the infrared light and recorded via thermocouples temporal temperature gradients in different depths.
